| TS-1089 | Adjusting the Label | Document Owner: | Effective Date: | Page 1 of 4 |
| | Gap Sensor (CAB A2+ | Service Department | AUG-22-2022 | |
| | on VX2/VXL/Solo) | | | |

This document provides the steps required to adjust the label gap sensor on the Cab A2+ printer on the Sci-Print VX2/VXL/Solo.

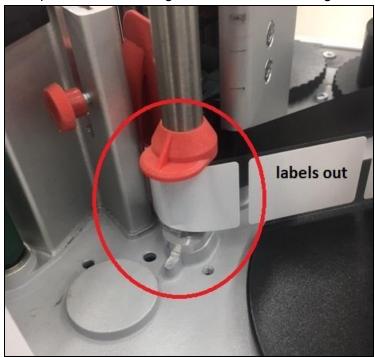
Figure 1.

1. Make sure the labels pass in front of the guide bar as shown in Figure 1 below.

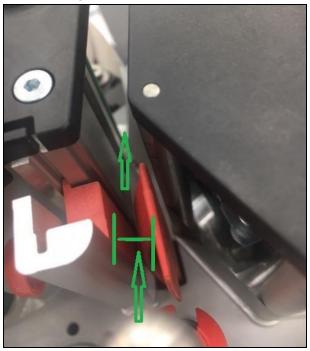
Figure 2.

2. Ensure the labels pass through the sensor.

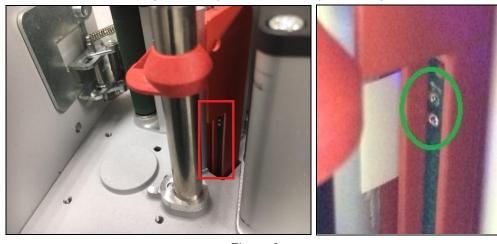
3. To ensure the sensor is positioned in the center of the label, align the marker on the rear of the sensor as shown in Figure 3. Adjust if needed by following steps 4 and 5.

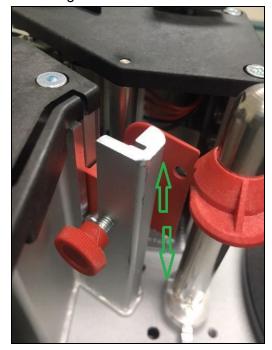
Figure 5.

5. Slide the sensor up or down to align on the center of the label.
