TS-1107	MP2 Chip and Board Replacement	Document Owner: Service Team	Effective Date: MAY-04-2023	Page 1 of 6
---------	--------------------------------	---------------------------------	--------------------------------	-------------

This guide explains the process of replacing a chip and the board in a Sci-Print MP2.

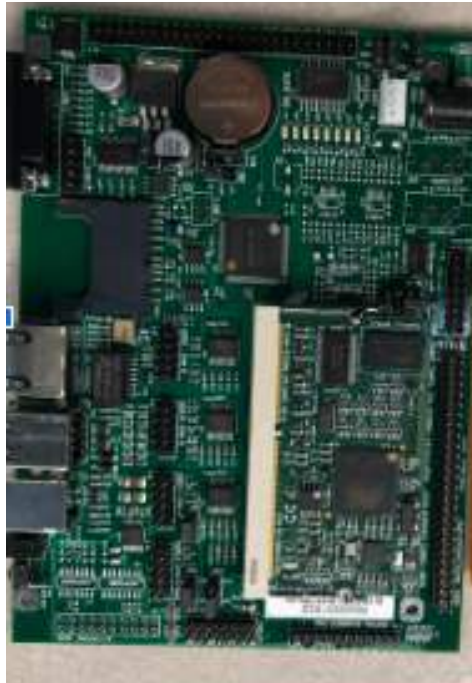
Figure 4.

3. The chip should now be seen mounted into the carrier board as shown in Figure 4 below.
4. If there are other cables in the way from removing the chip, note where they are connected and then remove to gain access to the chip.

**Note:** Figure 4 below does not show any cables, this will not be the case.

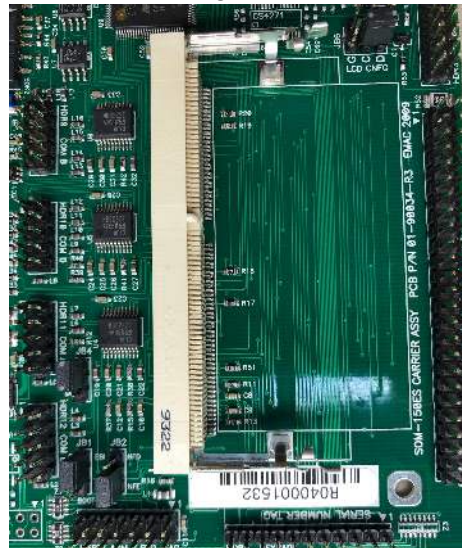
Figure 5.

5. Unlock the silver tabs holding the chip in place and lift up from the long side of the chip, opposite of the white connection slot. Figure 5 below shows the chip removed.

6. Insert the new chip by angling the connection side into the white slot, then push the chip down to a horizontal position until it locks into the metal clips.
7. Replace all 10 pin and 50 pin connections.
